Film-to-Glass Guide

Recommendations for Film-to-Glass Combinations

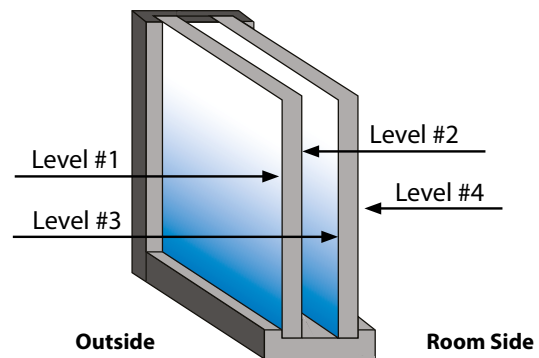
Side View of Dual Pane Insulated Glass (IG) Unit

#2 ▲²
Any interior LEC window film installed on a double pane insulated glass unit has a low risk of glass breakage if the low-e coating is on surface #3 and the Solar Heat Gain Coefficient (SHGC) is 0.61 (Shading Coefficient, SC 0.70) or less.

The following scenarios outline the necessary parameters when installing a Low-E Caution (LEC) film to an insulated glass (IG) unit. The Low-E Caution (LEC) indicates possible glass breakage and insulated glass (IG) unit seal failure, due to an increased risk when a LEC film is installed on a double pane, insulated glass (IG) unit with a Low-E coating.
